Procedia Structural Integrity 2 (2016) 541–548

21st European Conference on Fracture, ECF21, 20-24 June 2016, Catania, Italy

Internal and surface damage after electrochemical hydrogen charging for ultra low carbon steel with various degrees of recrystallization

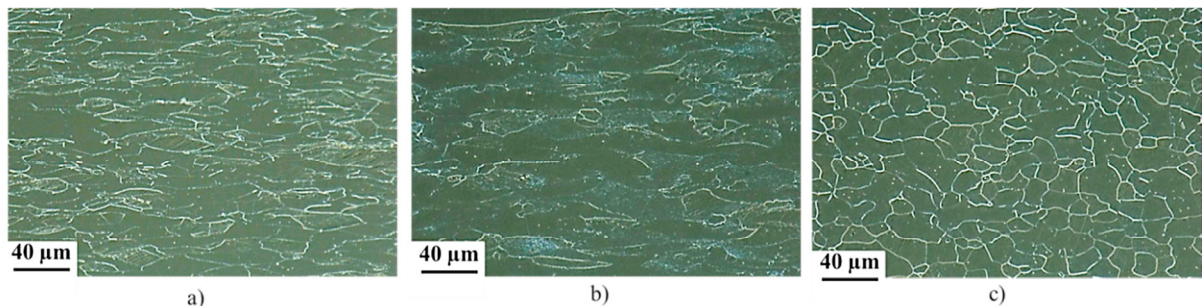
Fig. 1. Dark field optical microscopy images of the microstructure of a) cold deformed, b) partially recrystallized, and c) recrystallized ULC steel.

The hydrogen induced cracking behavior of an ULC steel with a chemical composition of 214 ppm C, 88 ppm N, 38 ppm S, 73 ppm P, 0.25 mass% Mn, 0.002 mass% Ti, 0.047 mass% Al was studied. The material consisted of ferrite grains, which contain a limited amount of hydrogen trapping site types, i.e. grain boundaries, dislocations and microvoids. Three microstructural states were tested: (1) 60% reduced by cold deformation, (2) partially recrystallized, and (3) fully recrystallized material. The corresponding microstructures are illustrated in Fig. 1. The recrystallized microstructure exhibited an average grain size of 14 μm .

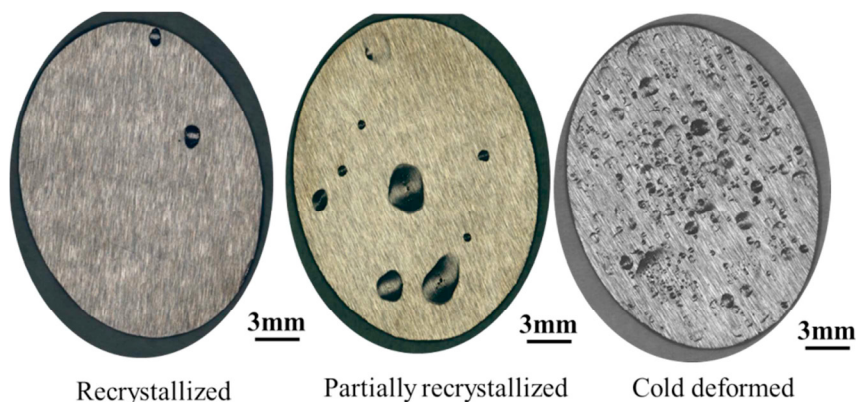
Fig. 3. Recrystallized, partially recrystallized and cold deformed ULC steel charged at 5 mA/cm^2 for 2 days.

Each microstructural state exhibited a different behavior when in contact with hydrogen. When the three materials were charged at 5 mA/cm^2 for two days, different amounts of blisters, blister sizes and shapes were observed (Fig. 3). The blistering behavior varied strongly between recrystallized and cold deformed material, while partially recrystallized material showed intermediate behavior, exhibiting characteristics of both extremes. With an increasing fraction of deformed microstructure, an increasing number of blisters formed and blister sizes equally rose. Additionally, a larger range of blister sizes was encountered in cold deformed ULC steel, with blisters covering a major part of the sample surface. Plastically deforming the material leads to the formation of dislocations and microvoids in the ferrite matrix, as such increasing the hydrogen trap density of the material (Pérez Escobar et al. (2012)). Hydrogen atoms can recombine to hydrogen gas in these specific locations (Garofalo et al. (1960)), which has a large impact on the blister initiation and propagation process. Their presence clearly facilitates blistering, making materials with a certain amount of deformation more sensitive to hydrogen induced cracking.

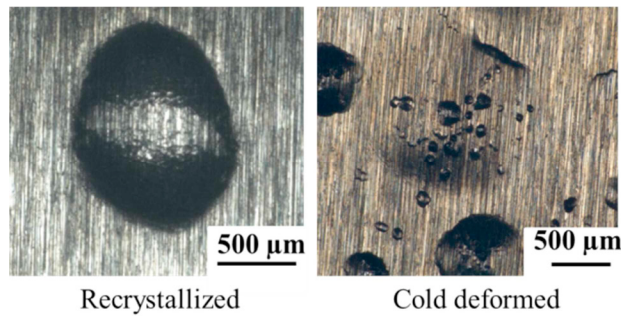
Fig. 4. Blister morphology of recrystallized and cold deformed ULC steel.

When considering the blister morphology in more detail (Fig. 4), several differences are observed. First, the blister's shape evolves from clearly delineated domes with an overall circular or oval shape for recrystallized material to less clearly defined blisters often only half emerging from the surface for deformed material. Blister caps of larger blisters are often covered with thin cracks. Second, the phenomenon of blisters on blisters was observed on the partially recrystallized and cold deformed samples. This phenomenon leads to a strongly non-homogeneous

blistering pattern on the surfaces of deformed ULC steel. The smaller blisters seem to concentrate mostly on larger blisters and in between these regions the density of small blisters is considerably lower. In material, that contains a certain fraction of deformed microstructure, blister initiation seems to occur preferably on previously existing blisters.

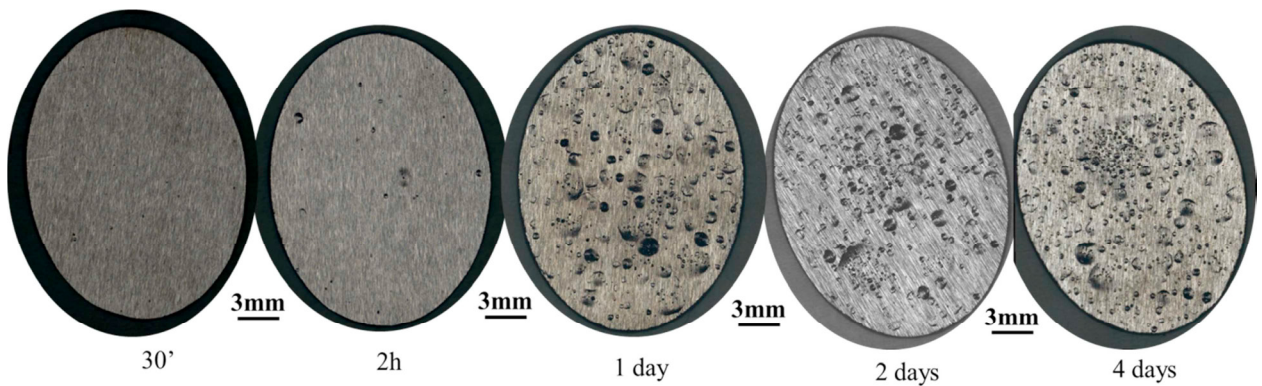
Fig. 5. Blister evolution in time for cold deformed ULC steel charged at 5 mA/cm².

Fig. 5 shows the blister evolution in time for cold deformed ULC steel charged at 5 mA/cm². Blistering starts with the formation of numerous small blisters (<50 μm). Longer charging times result in the appearance of larger blisters and simultaneous formation of small blisters. After 4 days of charging very large blisters (>4500 μm) appear in combination with numerous small and medium sized blisters. Such trends were observed for all three materials.

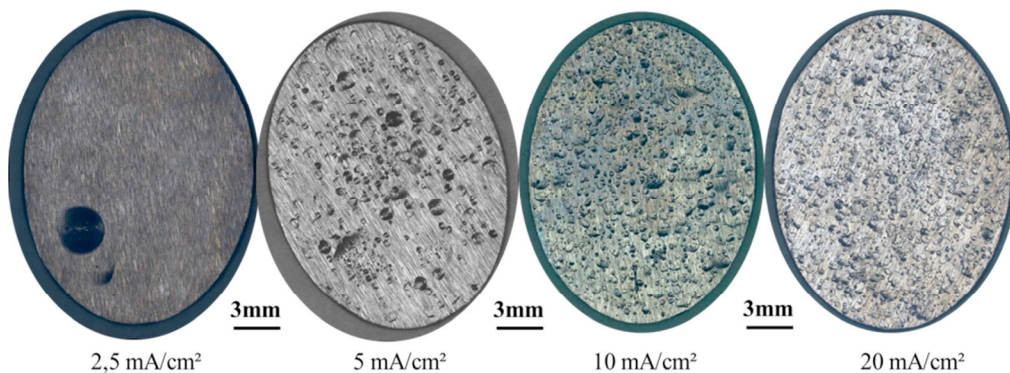
Fig. 6. Cold deformed ULC steel charged at various current densities for 2 days.

Additionally, samples were charged at 2.5, 10 and 20 mA/cm² for 2 days in order to assess the effect of the charging current on the blistering characteristics (Fig. 6). The number of blisters increased strongly with higher

current densities. The blister size increased up to 5 mA/cm² followed by a decrease for higher current densities. This was again observed for the three materials. The phenomenon of blisters on blisters seems to diminish at higher current densities, leading to a more uniform blister distribution on the surface. The blister shape evolves from well delineated domes to rather low plateau-like elevations with jagged edges. Higher current densities seem to shift the more favorable process from blister growth to blister initiation. More hydrogen is simultaneously incorporated in the material, activating more initiation locations instantaneously.

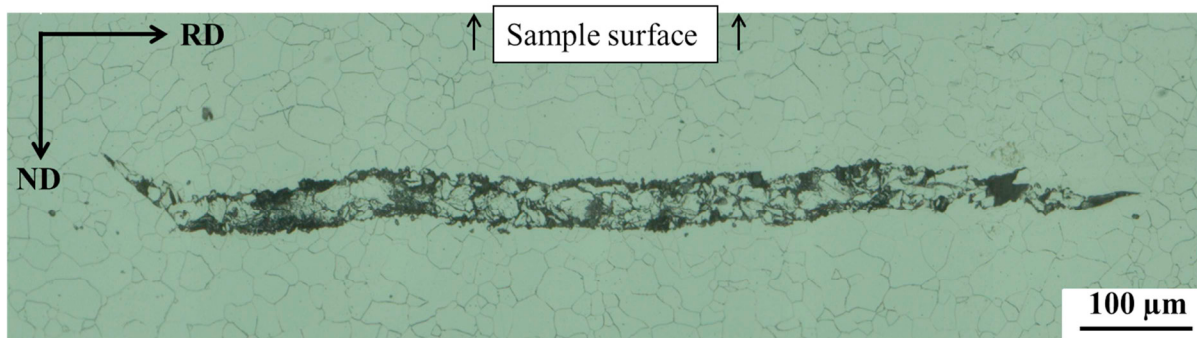
Fig. 7. Cross section of a blister in a recrystallized ULC steel charged at 5 mA/cm² for 4 days.

Multiple cross sections were taken from all charged samples in order to analyze the internal hydrogen induced damage. Overall, it was observed that if no blisters were present on the sample surface, no internal cracks were found in the interior of the material, which indicates that blister formation at the surface is more favorable than crack formation in the bulk of the material. In Fig. 7, the cross section of a blister found on the recrystallized material charged at 5 mA/cm² for 2 days is illustrated. The internal crack grew parallel to the rolling plane and to the sample surface, while crack tips deflected toward the sample surface. The observed crack actually consisted out of numerous thin cracks branching and connecting again, staying within a certain region as to form a sort of larger crack entity. As such, grains or parts of grains are enclosed in the crack entity. These observations equally account for cold deformed and partially recrystallized samples.

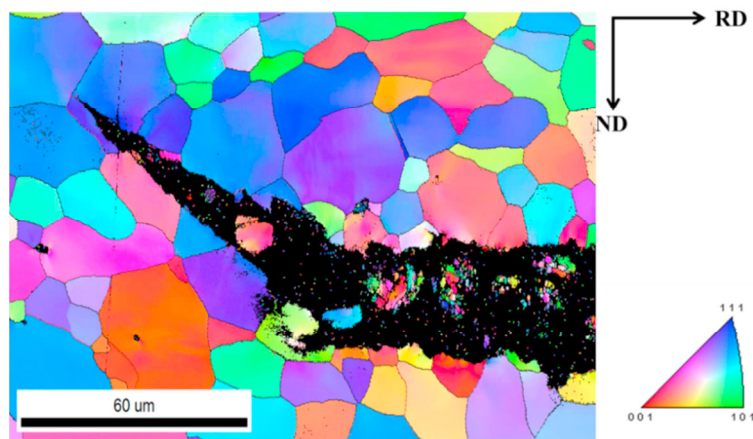
Fig. 8. ND Inverse pole figure of an internal crack in recrystallized ULC steel charged at 5 mA/cm² for 4 days.

Fig. 8 shows a ND inverse pole figure, on which one can see that the crack tip clearly propagates transgranularly. This observation was equally made for the other two materials. The enclosed material in the crack entity was strongly deformed, which is indicated by the high misorientations observed in these regions. Additionally, the crack entity is surrounded by locally increased misorientations. These two aspects are likely a result of the pressure build-up occurring in the cracks due to the hydrogen accumulation, as is the proposed hydrogen induced cracking mechanism by the internal pressure theory (Zapffe and Sims (1941)) (Tetelman and Robertson (1962)). The pressure build-up leads to plastic deformation of the surrounding material, resulting in local misorientations.
